Online THM Analyzer Helps Utility Optimize Operation and Validate Laboratory Results

The Brunswick & Topsham Water District (BTWD) in Maine was receiving high trihalomethane (THM) results despite implementation of best practices. This led to split samples of monitoring and compliance samples that resulted in conflicting analytical results. The percent difference of results from two laboratories undertaking THM analysis for the utility ranged from 65-98%. At the same time, BTWD installed an online THM analyzer to study supply and distribution management impacts on THMs, which resulted in a better understanding of operational impacts on THMs. The analyzer was also used to help evaluate the analytical results and build confidence in data being received from laboratories. The online THM analyzer helped reveal a performance error contributing to data biased high at one laboratory and small adjustments at a second laboratory resulting in all three analyses finally being within 10% of each other.

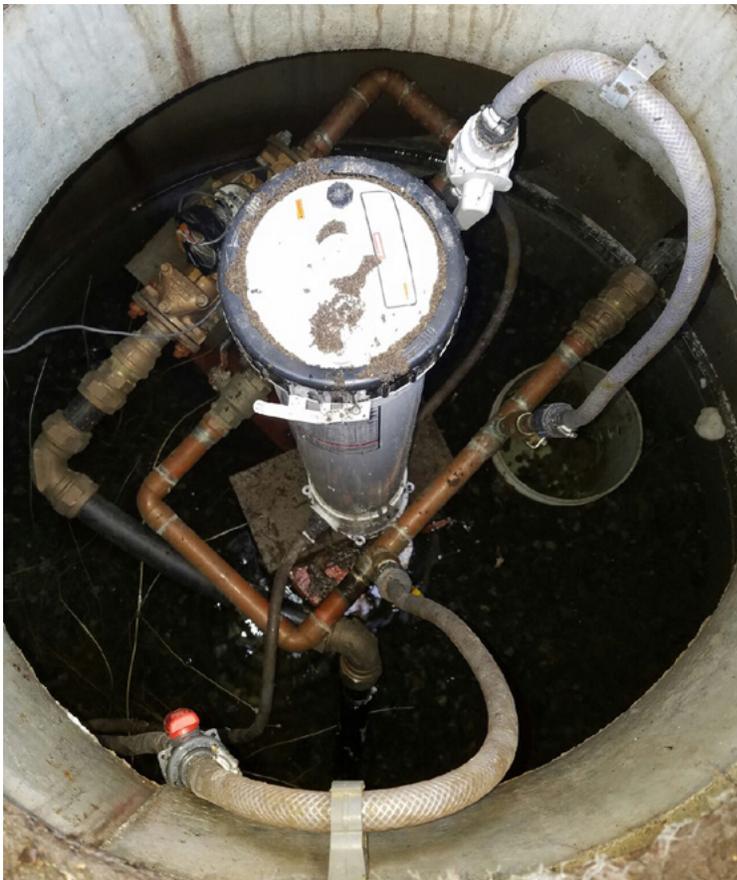
Figure 3: Typical Bleeder Vault Installation

Each of the vaults is installed with a throttling valve, dechlorinator, meter and backflow device (blocked from view by the dechlorinator). Staff is able to refill the dechlorinator with a non-permit confined space entry. The meter is connected to the District's remote read system.

- Operating levels were dropped by 10 feet in both of the District's water storage tanks resulting in a 25% decrease in stored water.
- Three bleeder vaults (Figure 3) were installed at the end of the three longest main runs that were fed by the Jackson facility Ivanhoe, Main St (NAPA Auto Parts) and Middlesex Rd (Lonnie's Hydraulics).
- Facility operations were adjusted to maximize production from the Taylor and Jordan Facilities and minimize production from the Jackson Facility.
